**Flood Control Project Maintenance
Levee Inspections**

Fall 2011 Levee Maintenance Deficiency Summary Report

Reclamation District No. 2103 Wheatland Vicinity

Levee Inspection Report By Mile - Fall 2011

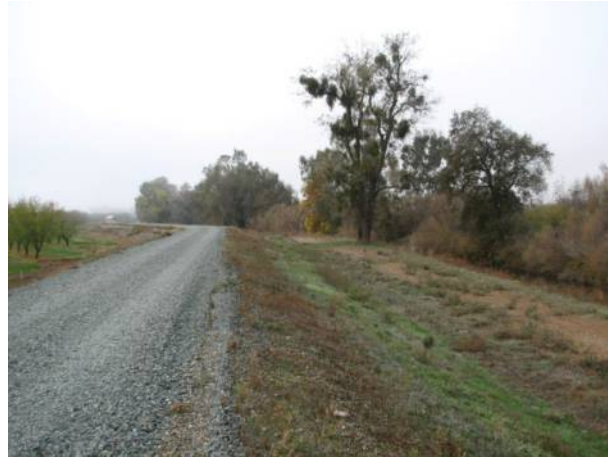
Levee Mile Report Line	1
Start Levee Mile	0.04
End Levee Mile	4.57
Location	Water Side
Category	Earthen Levee
Item	Vegetation

This photo shows the waterside vegetation at levee mile 2.60.

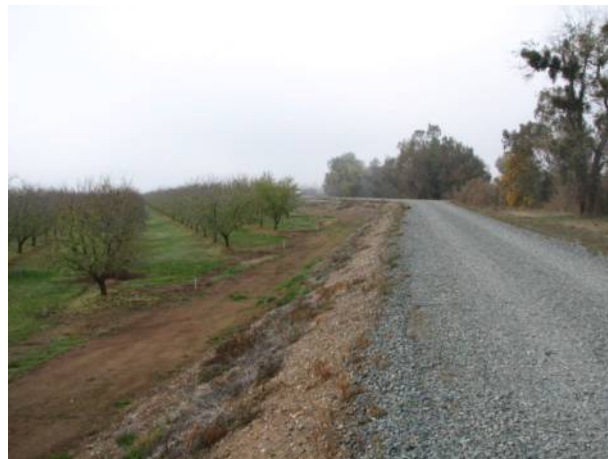
Levee Mile Report Line	2
Start Levee Mile	0.04
End Levee Mile	4.57
Location	Land Side
Category	Earthen Levee
Item	Vegetation

This photo shows the landside vegetation at levee mile 2.60.

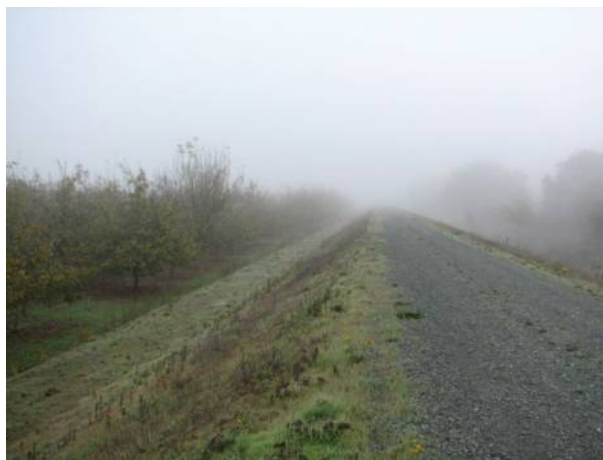
Levee Mile Report Line	1
Start Levee Mile	0.02
End Levee Mile	4.15
Location	Land Side
Category	Earthen Levee
Item	Vegetation

This photo shows the landside vegetation at levee mile 0.00.

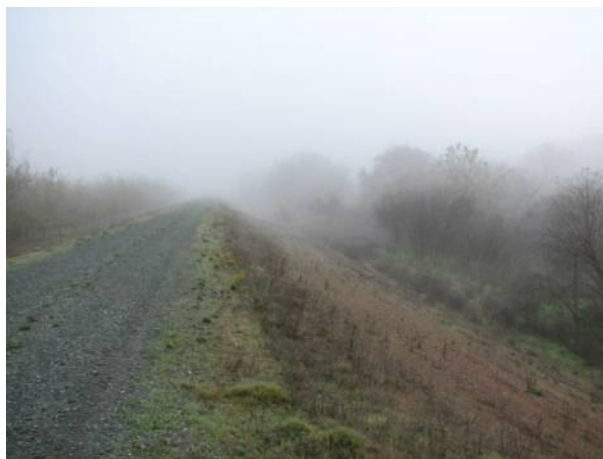
Levee Mile Report Line	2
Start Levee Mile	0.02
End Levee Mile	4.15
Location	Water Side
Category	Earthen Levee
Item	Vegetation

This photo shows the waterside vegetation at levee mile 0.00.

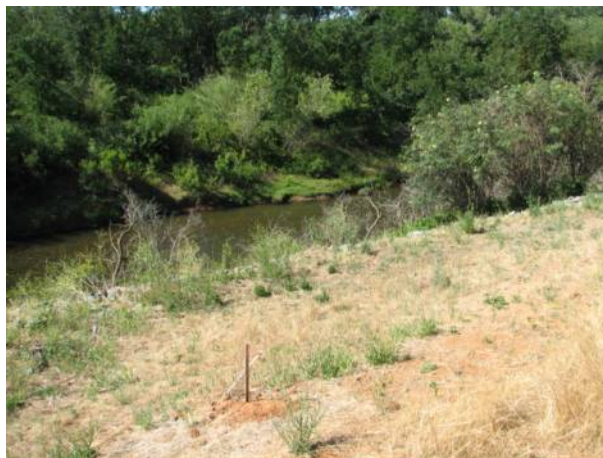
Levee Mile Report Line	3
Start Levee Mile	0.30
End Levee Mile	0.30
Location	Water Side
Category	Earthen Levee
Item	Rip Rap Revetments

Trees at waters edge in the rip rap levee mile 0.30.

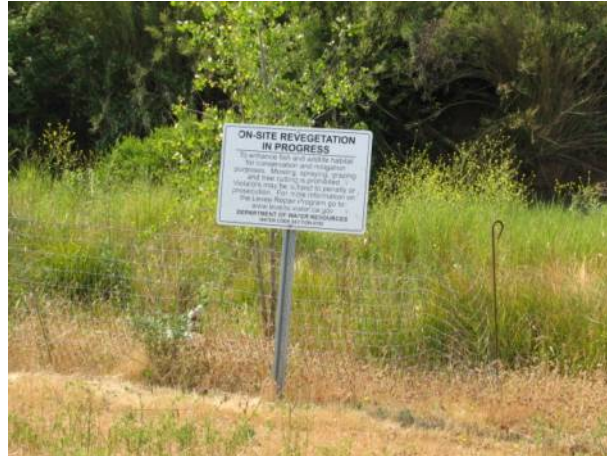
Levee Mile Report Line	4
Start Levee Mile	0.33
End Levee Mile	0.50
Location	Water Side
Category	Earthen Levee
Item	Encroachments
Levee mile 0.33, this photo is looking at the landscaping, vegetation on the waterside slope	
cathom_f_20110929_655.jpg
